# Manhole Inspection Summary

Manhole # S29EE2001MH

Insp Date: **12/5/06 10:43 AM**

**Location** Address: **11 MELROSE AVE**

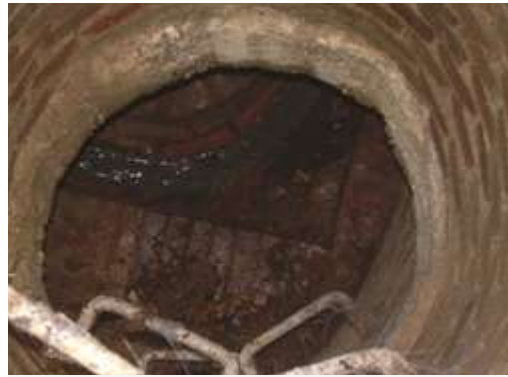
Top View

☐ Parged ☒ **Debris** (not Condition related)

☒ **Evidence Of Surcharge** Depth: **1** (ft.) ☐ Active Surcharge Present

Evidence of surcharge - Bench debris.

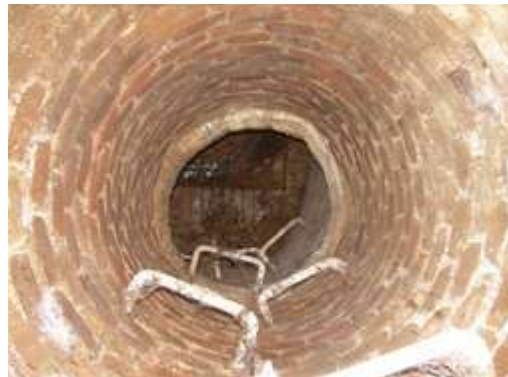
Defect

Infiltration: ☐ None ☒ **Joint** ☐ Cracks ☐ Mortar ☐ Roots ☒ **Wall**

Infiltration: ☐ None ☐ Joint ☐ Cracks ☒ **Mortar** ☐ Roots ☒ **Wall**

Adjustment, Corbel and Barrel infiltration.

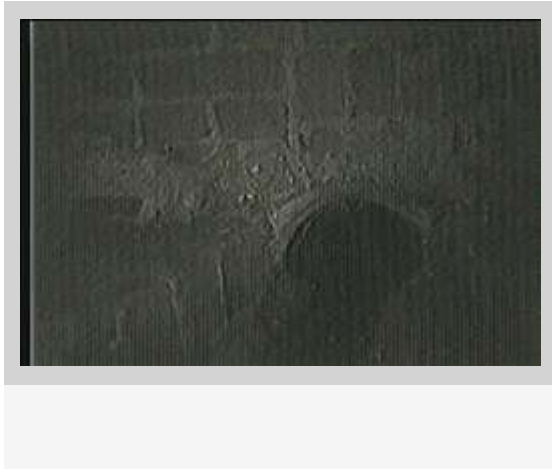
### Pipe Out @ 12 O'Clock

Pipe Material: ☐ Pipe Lined  
Invert Depth: (ft.) Flow Characteristics: **Slow**  
Deposits: ☐ None ☒ Mud ☐ Sludge ☒ Debris ☐ Grease  
Silt Depth: 1 (in.) Deposits Extent: **Light**  
Infiltration: **Evidence** Pipe Seal Cond: **Unknown**

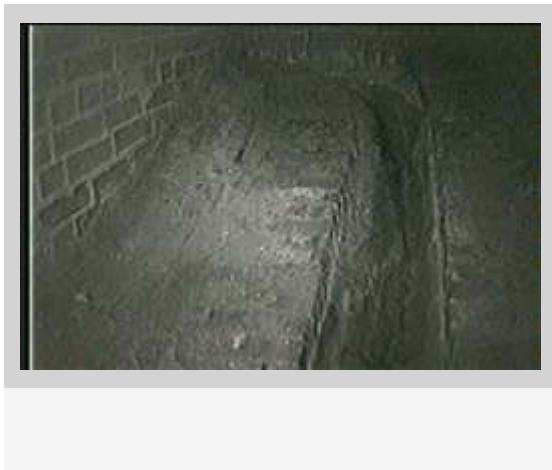
### Pipe In @ 6 O'Clock

Pipe Material: ☐ Pipe Lined  
Invert Depth: (ft.) Flow Characteristics: **Slow**  
Deposits: ☒ None ☐ Mud ☐ Sludge ☐ Debris ☐ Grease  
Silt Depth: (in.) Deposits Extent:  
Infiltration: **None** Pipe Seal Cond: **Unknown**
